APPENDIX J
HISTORIC ARCHITECTURE REPORT

HISTORIC ARCHITECTURE REPORT
for
COLUSA POWER PLANT PROJECT
COLUSA COUNTY, CALIFORNIA

Attachment J1 DPR 523 Records

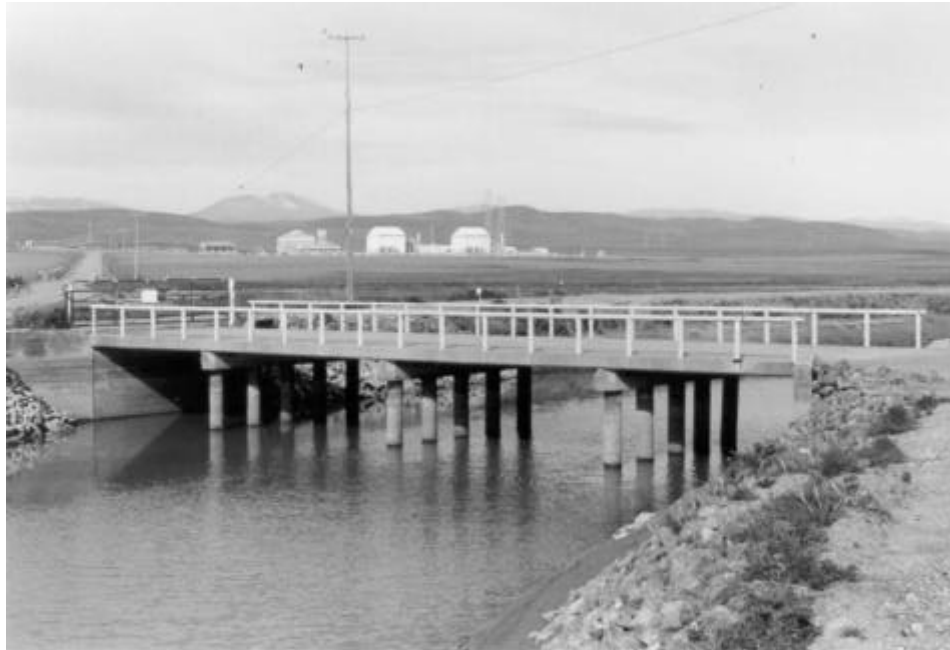
A one and one half to two mile portion of the Glenn-Colusa Canal is located within or borders the APE for this project. The canal is dirt lined with rock or rubble rip rap at the bridge abutment at Dirks Road. There is a levee on either side of the canal and a dirt maintenance road on top of each levee.

Photo 2. View NW of Canal and Bridge at Dirks Road, 11 March 2001. BRV 2:7. Brian Vahey, photographer.

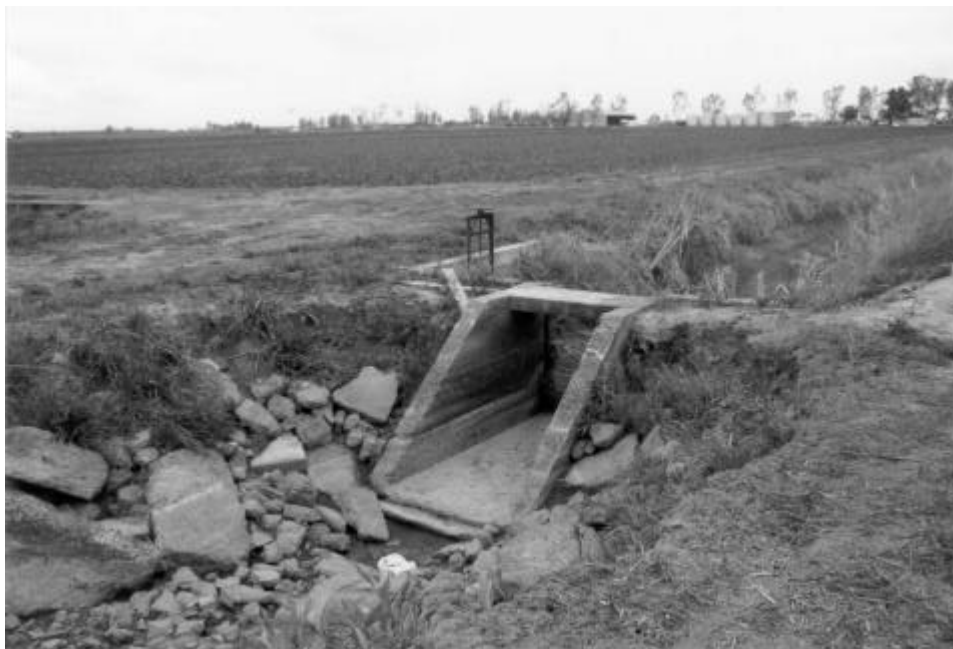
Photo 3. View of typical ditch and concrete diversion structure located on east side of McDermott Road south of Delevan Road; 6 March 2001. DB 1:5. Denise Bradley, photographer.

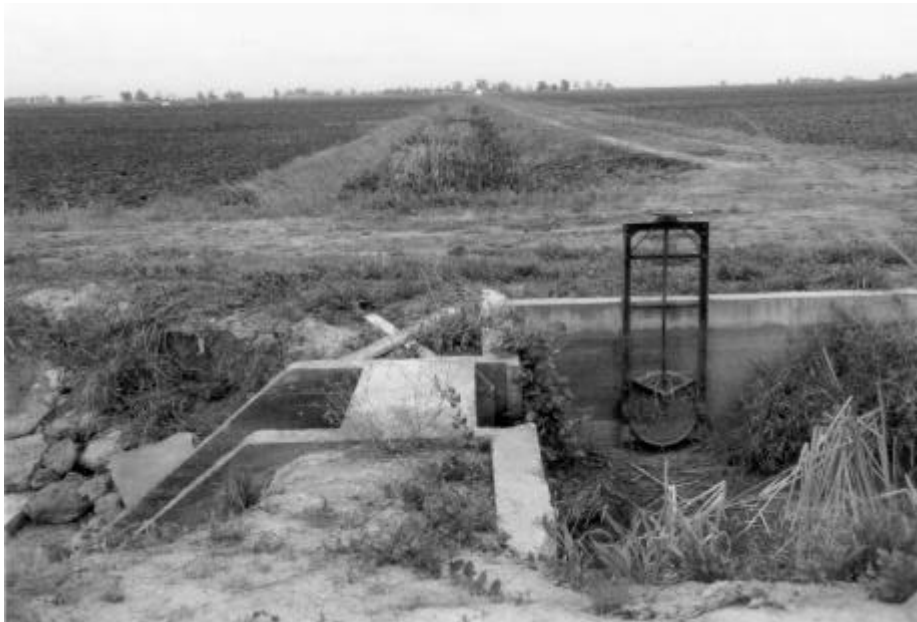
Photo 4. View of typical gate structure located on east side of McDermott Road south of Delevan Road; 6 March 2001. DB 1:6.
Denise Bradley, photographer.

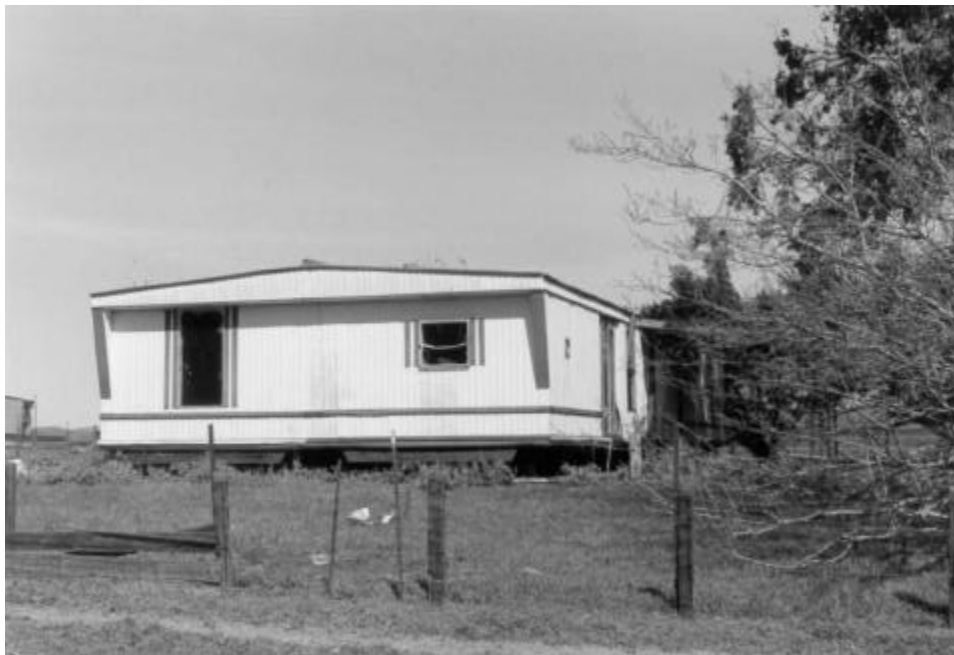
2. A double-wide, manufactured home is also located on the site. The one-story structure has a rectangular footprint and is raised off the ground on blocks. The structure is covered with vertical aluminum siding. The building has a shallow gabled roof that is supported by brackets under the gable ends. The building is badly deteriorated, and the frames and glazing of the windows are missing. Post 1960.

2. Manufactured Home: view north, 11 March 2001. BRV-2:21. Brian Vahey, photographer.

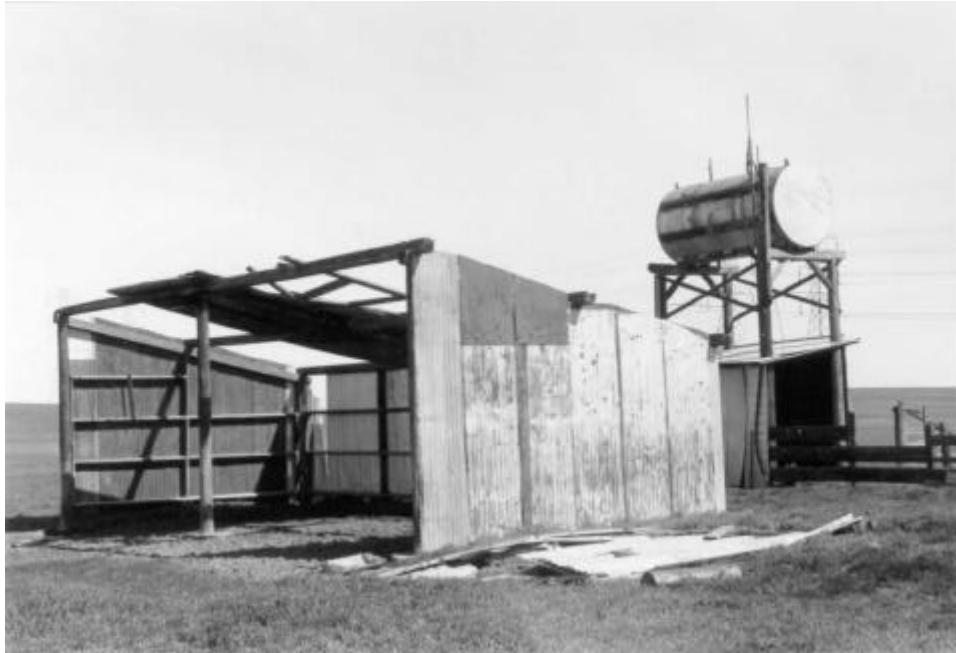
4. A rectangular wood frame structure with a shed roof. The walls are sheathed in corrugated metal panels and the roofing is missing. One side of the building has been left open. The floor is dirt. Post 1960.

4. and 5. Shed and tank: view northeast, 11 March 2001. BRV-2:24. Brian Vahey, photographer.

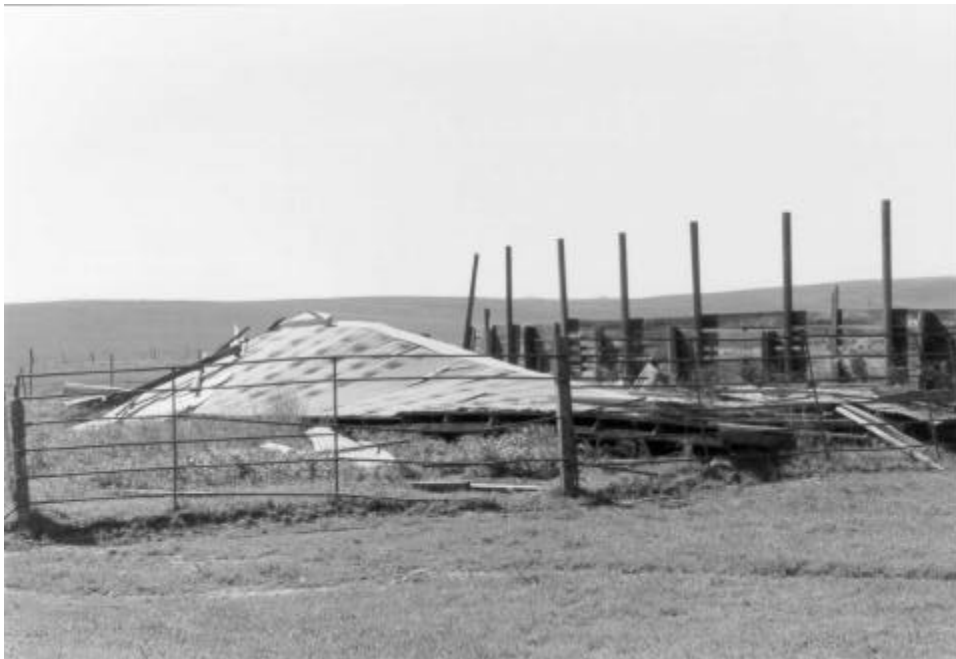
6. Collapsed Building: view south, 11 March 2001. BRV-2:23. Brian Vahey, photographer.

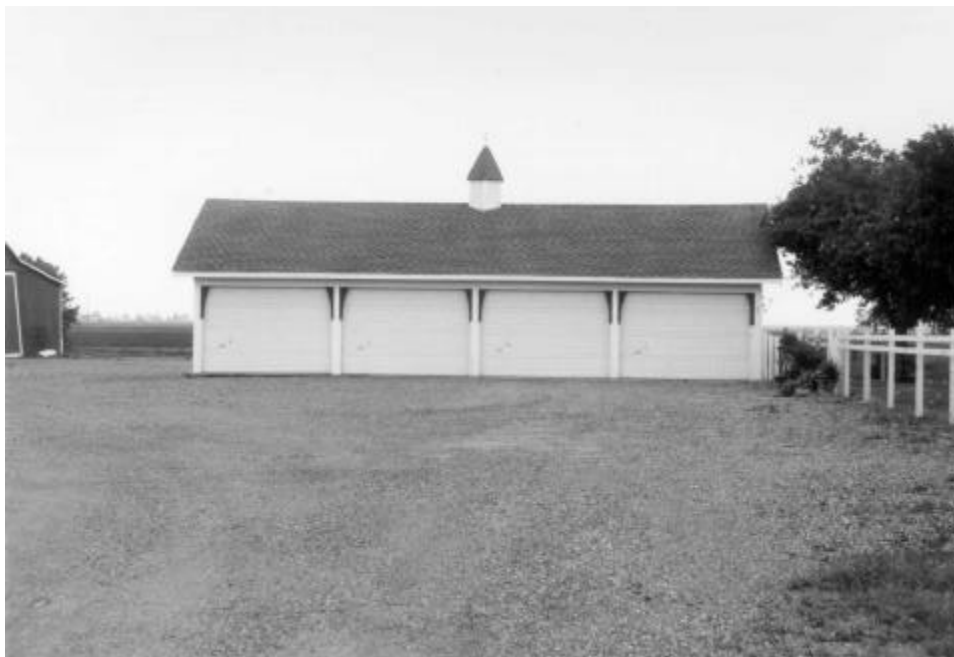
4. Between the two houses is a rectangular four-bay garage for domestic use. This is a recent building with a cupola on the gable roof. It is a wood frame structure.

4. Domestic Garage. view south, 6 April 2001, DB-1:20. Denise Bradley, photographer.

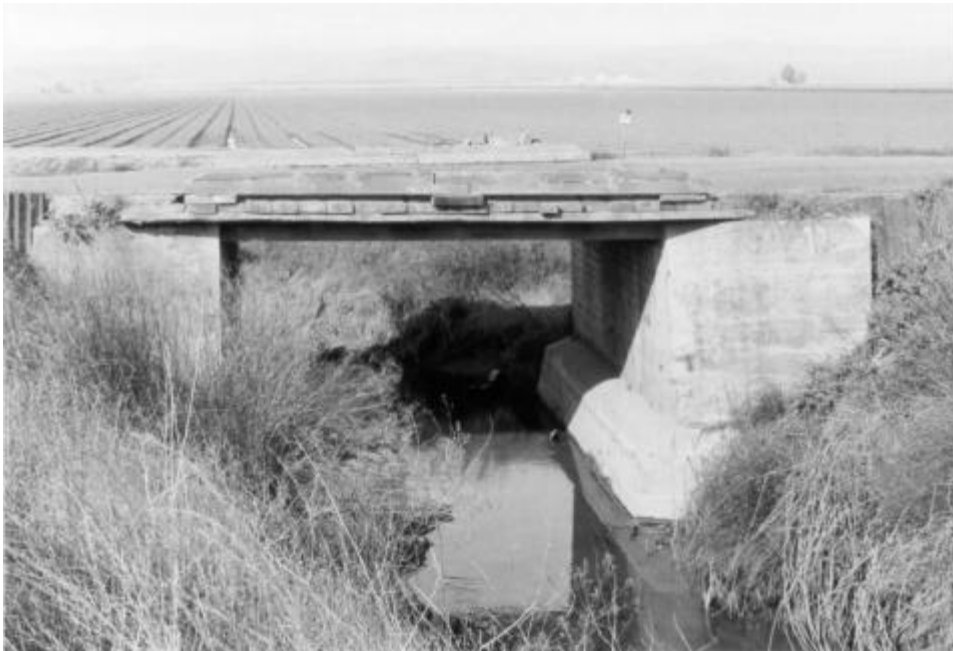
1940; repaired 1959/Caltrans

The Teresa Creek Bridge is located on a section line road that appeared on a 1906 USGS map. The current bridge was built about 1940, apparently replacing an earlier structure. A 1949 Thomas Brothers map showed this bridge in an area served by a network of improved roads. The bridge was repaired in 1959.

In 1980, a California Department of Transportation Bridge Report described it as follows: "The structure is in poor condition . . . The planks are very worn. Outer stringers have some incipient rot, near ends." A handwritten note on the Bridge Report stated: "Removed from biennial inspection process in re letter dated 10-10-85."

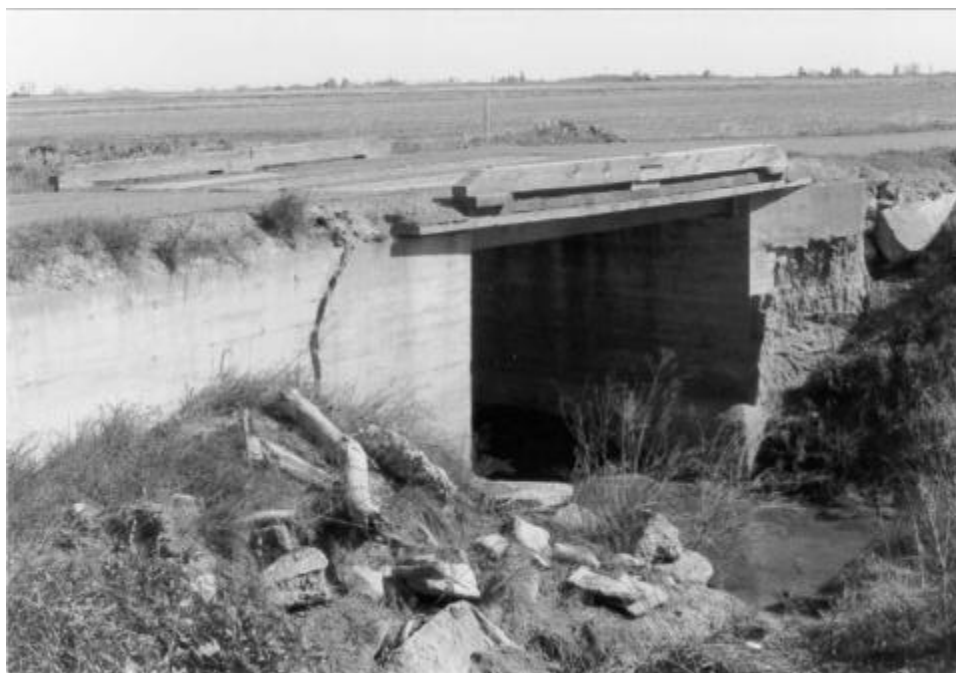
This is a wood bridge that spans between concrete abutments — by definition, a “simple bridge,” as distinct from more complex types of bridges classified as continuous, cantilever, arch, and suspension bridges. A 1980 California Department of Transportation report described it as follows: “Timber deck, on timber stringers, on RC wing abutments.” According to the *American Civil Engineer’s Handbook* (p. 1668), “Wooden bridges resting on concrete piers and abutments are in very common use.” The abutments are poured concrete structures with the exposed imprints of formboards, straight sides, and a curb-like base. The west faces of these abutments are cracked and spalling where they meet the flow of water in the creek. The abutments are spanned by 3- by 8-inch wood stringers 18.4 feet long. The deck consists of two layers: 4- by 8-inch timbers laid across the stringers, and a top layer of boards and asphalt. The deck of the bridge is flat and flush with the road. The east and west sides of the bridge have curbs made of 10- × 10-inch timbers.

View southeast. 11 March 2001. BRV-2:35. Brian Vahey, photographer.
